# BARBADOS SARGASSUM ADAPTIVE MANAGEMENT STRATEGY (SAMS)

## VOLUME 2: ACTION APPENDICES

April 2023

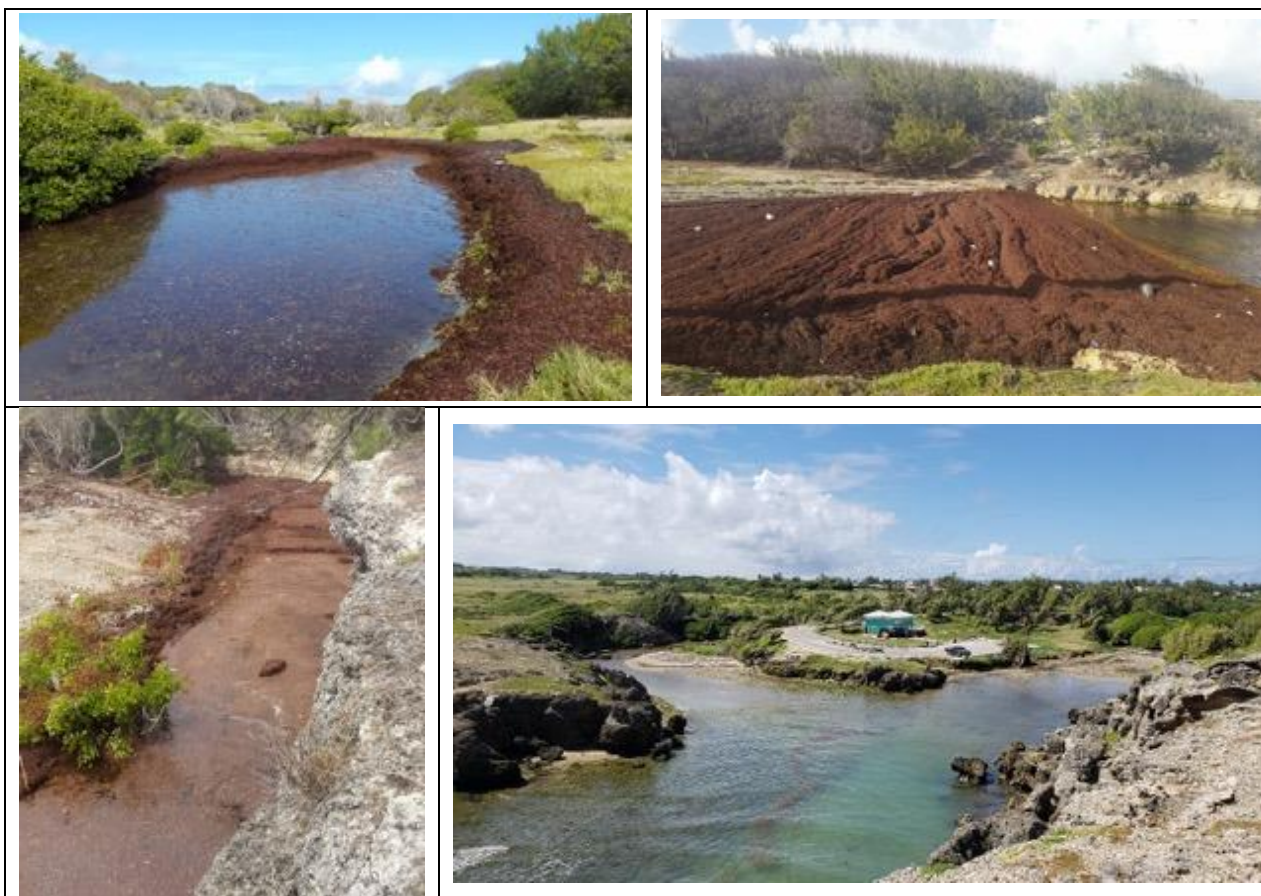
River Bay has been one of the most significantly impacted areas since the advent of mass sargassum inundation. The presence of freshwater promotes the anaerobic degradation of sargassum and the prevailing winds carry the smell to the nearby community which is upwind. The use of the bay has declined significantly. Once sargassum comes into the bay, because of the low internal wave energy and the narrow mouth, it is not removed naturally. Without human intervention the sargassum would remain for months. Given the importance of the beach to locals, the proximity of the nearby community inclusive of hospital, quarantine center and churches, the positioning of the bay and the limitations affecting natural removal, River Bay displays a **HIGH vulnerability** to influx events.

No evidence was found to support increased resilience of the River Bay community to sargassum influx events. Significant on-going efforts have been made to remove the sargassum as it enters the bay, but these efforts are limited by a scarcity of resources and equipment and come at a significant cost to the agencies involved. While these efforts have been successful in mitigating the worse of the impact of sargassum in the bay, they are not sustainable. As a result, River Bay demonstrates **LOW resilience**.

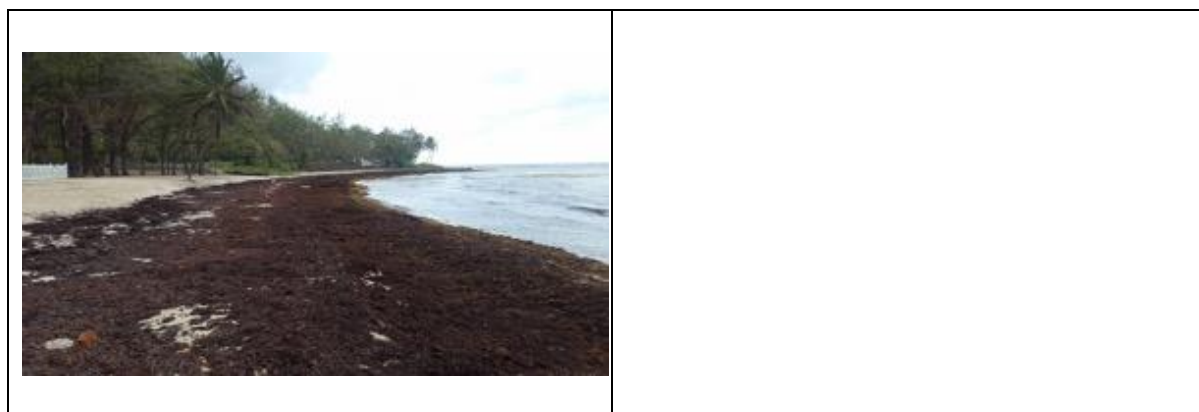
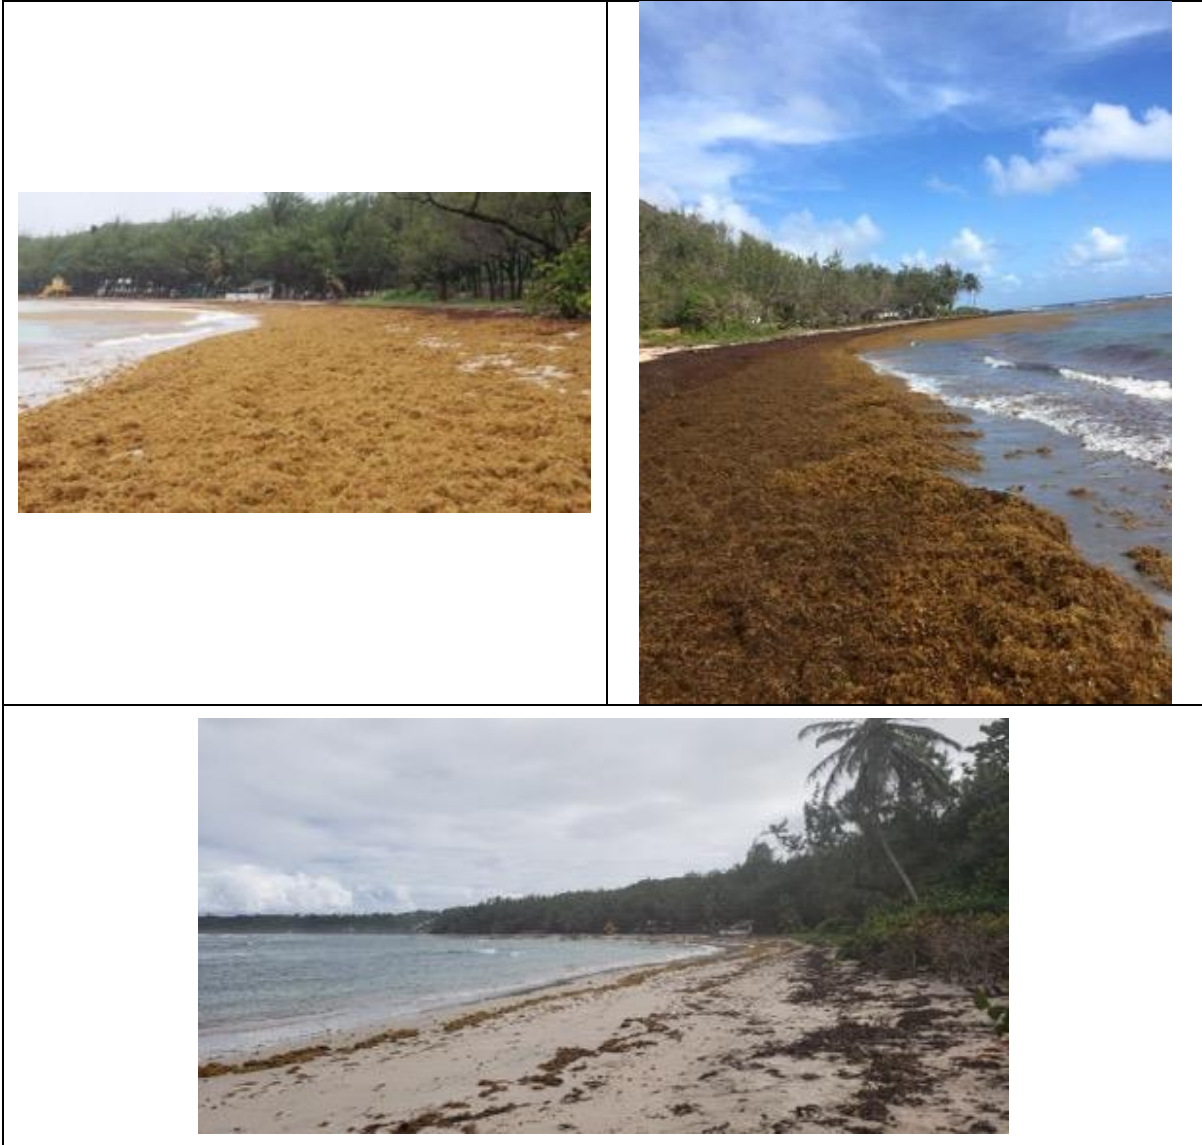
Geophysical features at Bath beach and the typically low wave energy reduces the likelihood of sargassum being removed naturally. While there are no permanent residents at the bay, the presence of degrading sargassum affects the rental of the bay houses as well as local use of the popular picnic spot. Bath beach has a **MEDIUM/MODERATE vulnerability** to the impacts of sargassum during influx events.

No evidence was found to support increased resilience of the Bath community to sargassum influx events. There are no active community groups engaging in cleaning and no sections of the beach are cleaned by property owners. Cleaning thus far has been dependent on the activities of government agencies. As a result, Bath beach demonstrates **LOW resilience**.

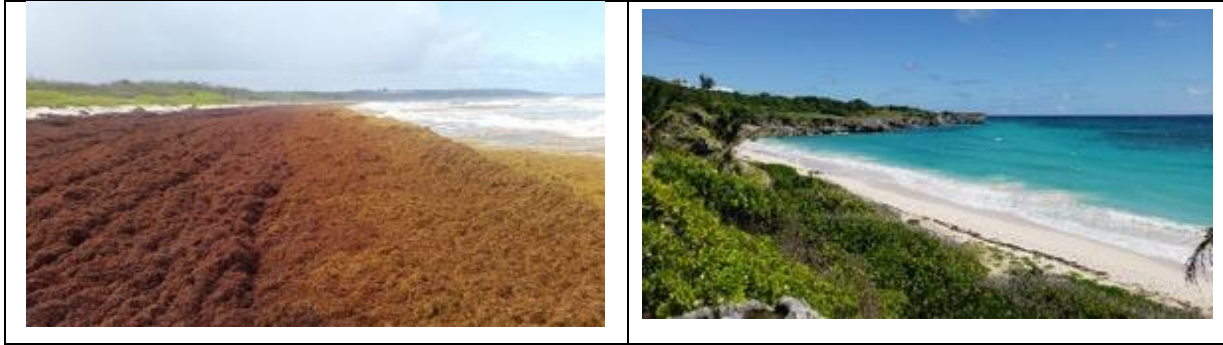
The nearby Inch Marlow community is susceptible to the smell caused by decomposing sargassum and its associated health impacts, however, there are no livelihoods directly impacted. The beach and associated sensitive habitats have, in the past, been negatively impacted by cleaning efforts. Given the remote and undeveloped nature of the beach, the community displays a **MODERATE to LOW vulnerability** to influx events.

Since the arrival of sargassum there have been numerous attempts made to tackle the vast amounts of sargassum, but most have proven ineffective and some damaging. It has become apparent that natural removal and aids to natural removal may be the best option at this location. Long beach demonstrates **MODERATE to HIGH resilience**.

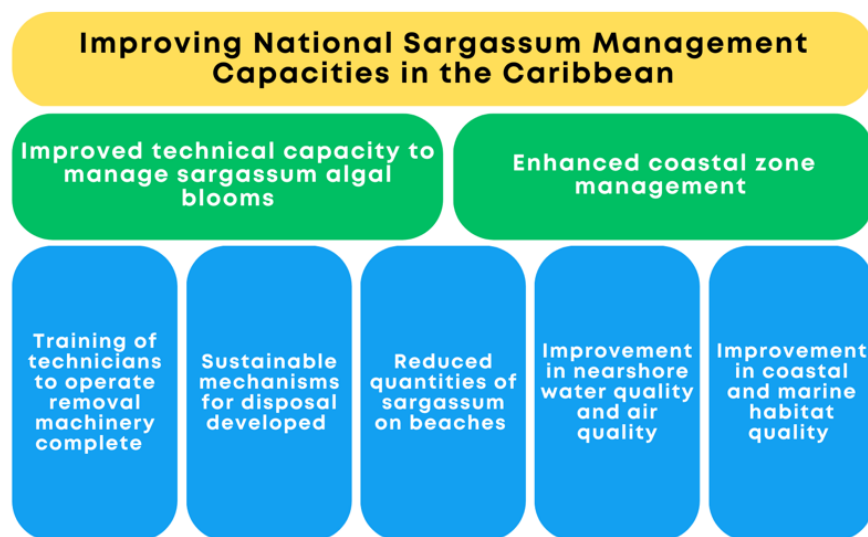
Over the years various collection techniques were tried and tested, with many lessons learned, as highlighted in the various guidance documents presented in the previous section. A systems approach is essential for improving national capacities for sargassum management. It is assumed that if mechanisms to support the effective and continuous collection of sargassum seaweed are implemented, and the technical capacity for sargassum removal is increased, then the resilience of coastal areas will be improved<sup>2</sup>. The figure below illustrates further<sup>3</sup>.

Source: UNDP. 2022. Project Document- Improving National Sargassum Management Capacities in the Caribbean.

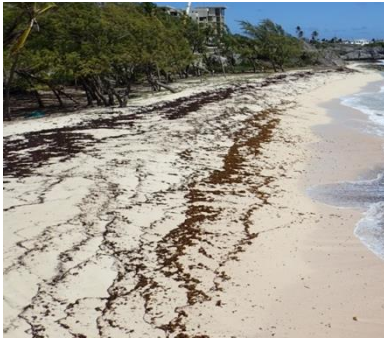
**Low-** just a small amount of sargassum. Sparse, less than 2 inches in depth. Faint seaweed odor. Small amounts of sargassum on the beach will do no harm and may not require intervention.

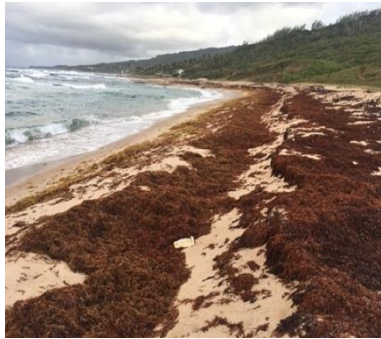
**Medium–** About 6 – 9 inches in depth. Strong odor, several insects. Moderate amounts may also not require intervention.

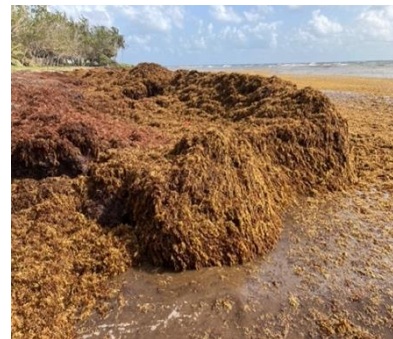
**High–** more than 10 inches in depth. Pungent odour, significant impairment of movement of vessels and use of beachfront. Large inundations need to be cleared quickly (within 24-72 hours).

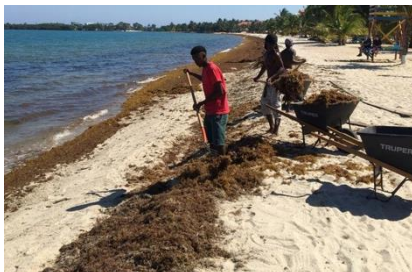
Removal can either be manual using rakes, wheelbarrows and buckets, or mechanized using machinery such as surf rakes, excavators and other heavy machinery. While manual removal is a preferred method, mass strandings will require the use of mechanical equipment, or a combination of both.

Belize (2018). Credit: Caribbean Press Releases

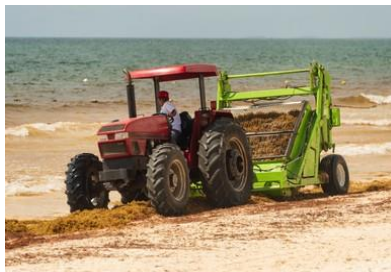
The Barber Surf Rake at Playa Paraiso, Tulum, Mexico (2018). Credit: Marc Bruxelle

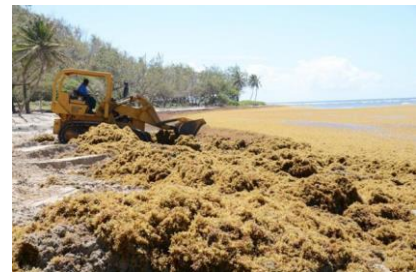
Bath Beach, St. John, Barbados (2018). Credit: The Barbados Advocate

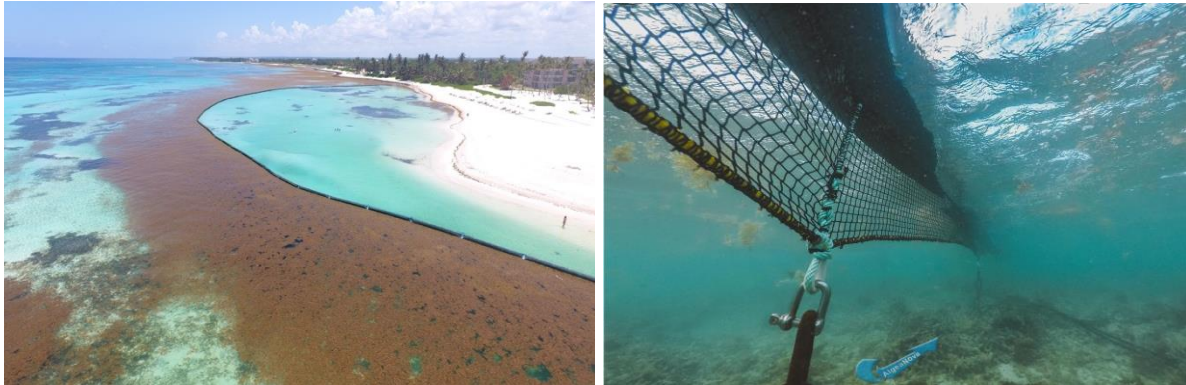
Source: Algeanova- Offshore barriers designed and deployed by Algeanova in the Dominican republic.

In-water collection close to shore, where possible and permitted, is often preferable to beach collection as it avoids removal of sand and damage to coastal vegetation. It may also prevent sargassum from rotting in the water (Hinds et al. 2016). Offshore barriers and boat harvesters are the methods commonly used for in-water collection. A combination of the offshore barrier and harvest barge yield optimal results. Offshore barriers work either through diversion away from sensitive areas or through storage and containment.

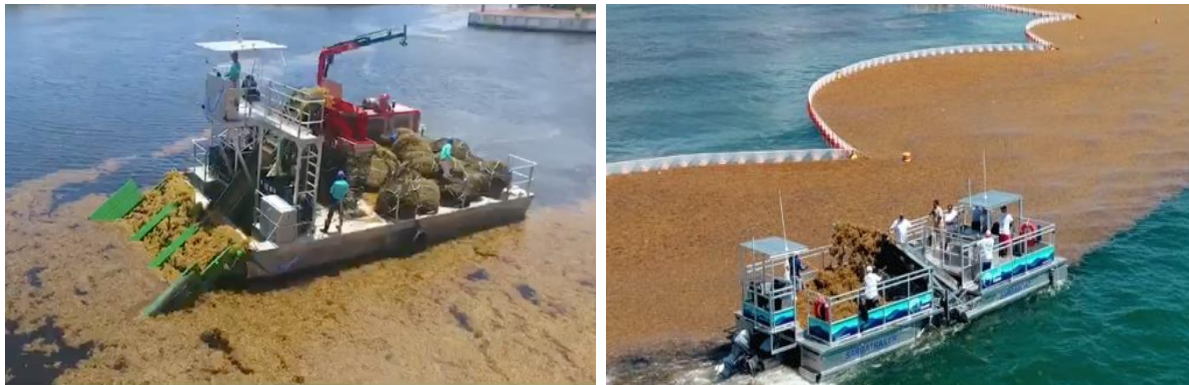
Source: Algeanova- Custom built Algeanova boat harvester operating in Dominica Republic

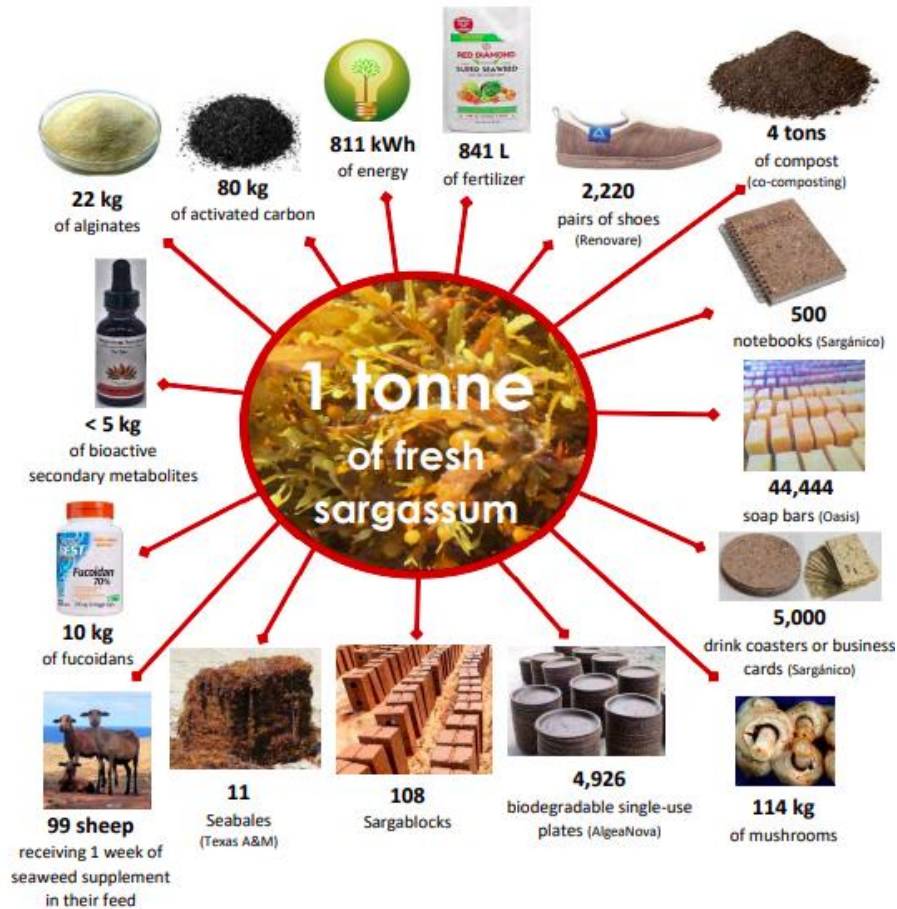
The Sargassum Uses Guide<sup>5</sup> remains the most comprehensive and authoritative resource on potential applications of sargassum biomass. Potential uses were identified across 14 different sectors, including agriculture, biofuels, cosmetics, bioplastics, construction, pharmaceutical, among others. Below shows Sargassum Biomass Index, illustrating the relative product yields that could potentially be produced from one metric tonne (1000 kg) of fresh sargassum. Click [here](#) to access the full document.
